APOLLO PROGRAM

FINAL FLIGHT EVALUATION REPORT APOLLO 6 MISSION

FEBRUARY, 1969

NATIONAL AERONAUTICS AND SPACE ADMINISTRATION

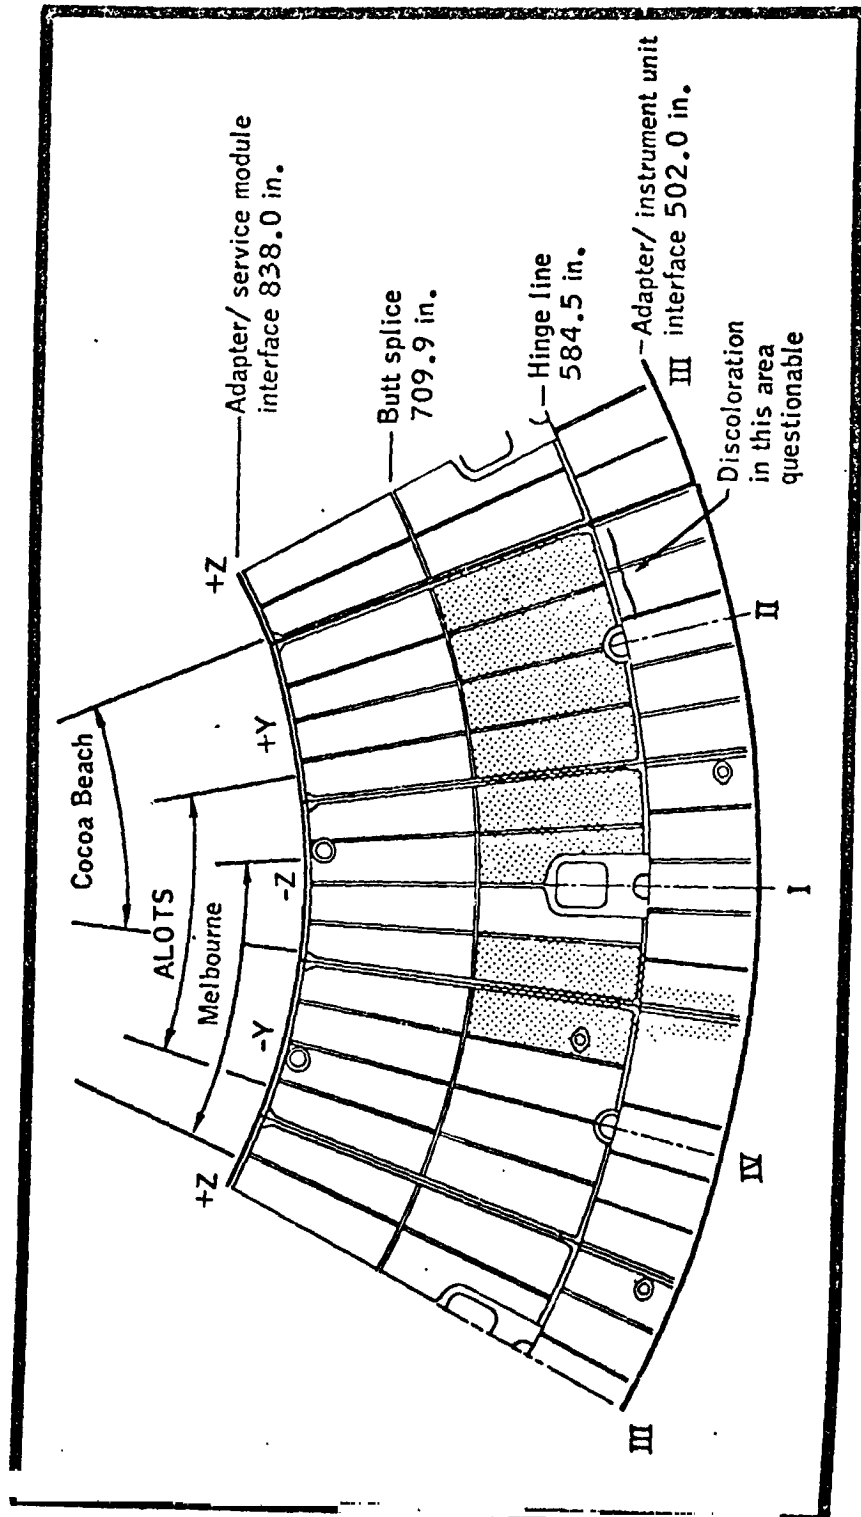
Figure 2.1.1-1. Photographic Coverage of SLA Showing Approximate Area of Color Change

A DARK AREAS WHICH APPEARS ON THE SLA AT 00:02:13 IS SHOWN SCHEMATICALLY IN FIGURE 2.1.1-1. THE DARK AREA IS MORE THAN TWICE THE AREA OF THE PIECES SEEN FALLING FROM THE SLA; CONSEQUENTLY, THE REMAINDER OF THE DARK AREA MUST HAVE BEEN LACK OF REFLECTION FROM A PERMANENT DEFORMATION OF THE SLA SURFACE. DENSITOMETER CONTOURS OF FAILED AREA WERE STUDIED. BECAUSE OF THE SHAPE OF THE TERMINATORS IT MAY BE PRESUMED THAT CONTOURS REPRESENT INWARD BUCKLING.

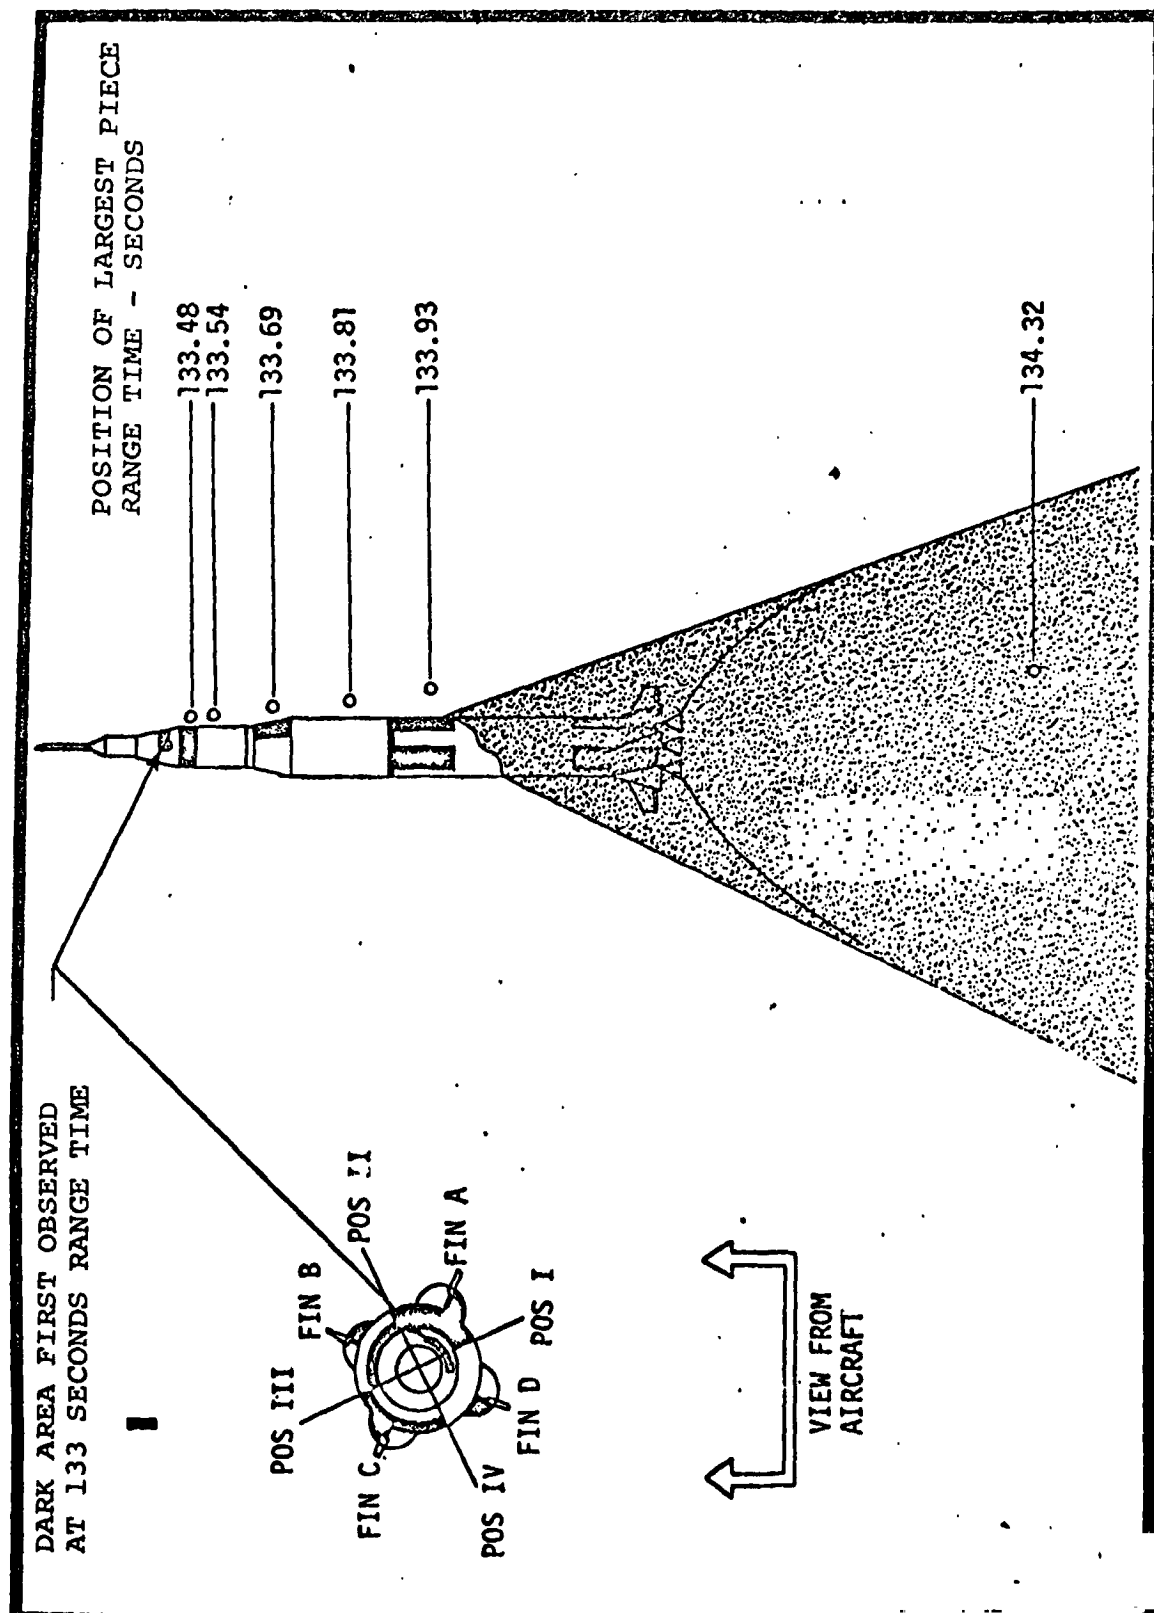
FIGURE 2.1.1-2 PLOT OF LARGEST PIECE - ALOTS 70 MM FILM - 133 TO 135 SECONDS RANGE TIME

SEPARATION OF THREE SMALL AND FIVE OR SIX LARGE PIECES OF SHEET MATERIAL FROM THE SURFACE OF THE ADAPTER WAS OBSERVED FROM 02:13:31 TO 02:13:68. THE APPROXIMATE POSITIONS OF THE LARGEST OF THESE PIECES ARE SHOWN IN FIGURE 2.1.1-2, ALONG WITH THE CORRESPONDING RANGE TIME FOR EACH POSITION. SOME PIECES BROKE UP INTO SMALLER PIECES WHEN PASSING THROUGH THE MORE TURBULENT AREAS. AT LEAST ONE SURFACE OF EACH PIECE WAS HIGHLY LIGHT-REFLECTIVE.

TRAJECTORY ANALYSIS WAS USED TO ESTIMATE THE MATERIAL PROPERTIES OF TWO OF THE PIECES OBSERVED FALLING FROM THE SLA. IT HAS BEEN CONCLUDED THAT THEY WERE PIECES OF ALUMINUM STRUCTURE.

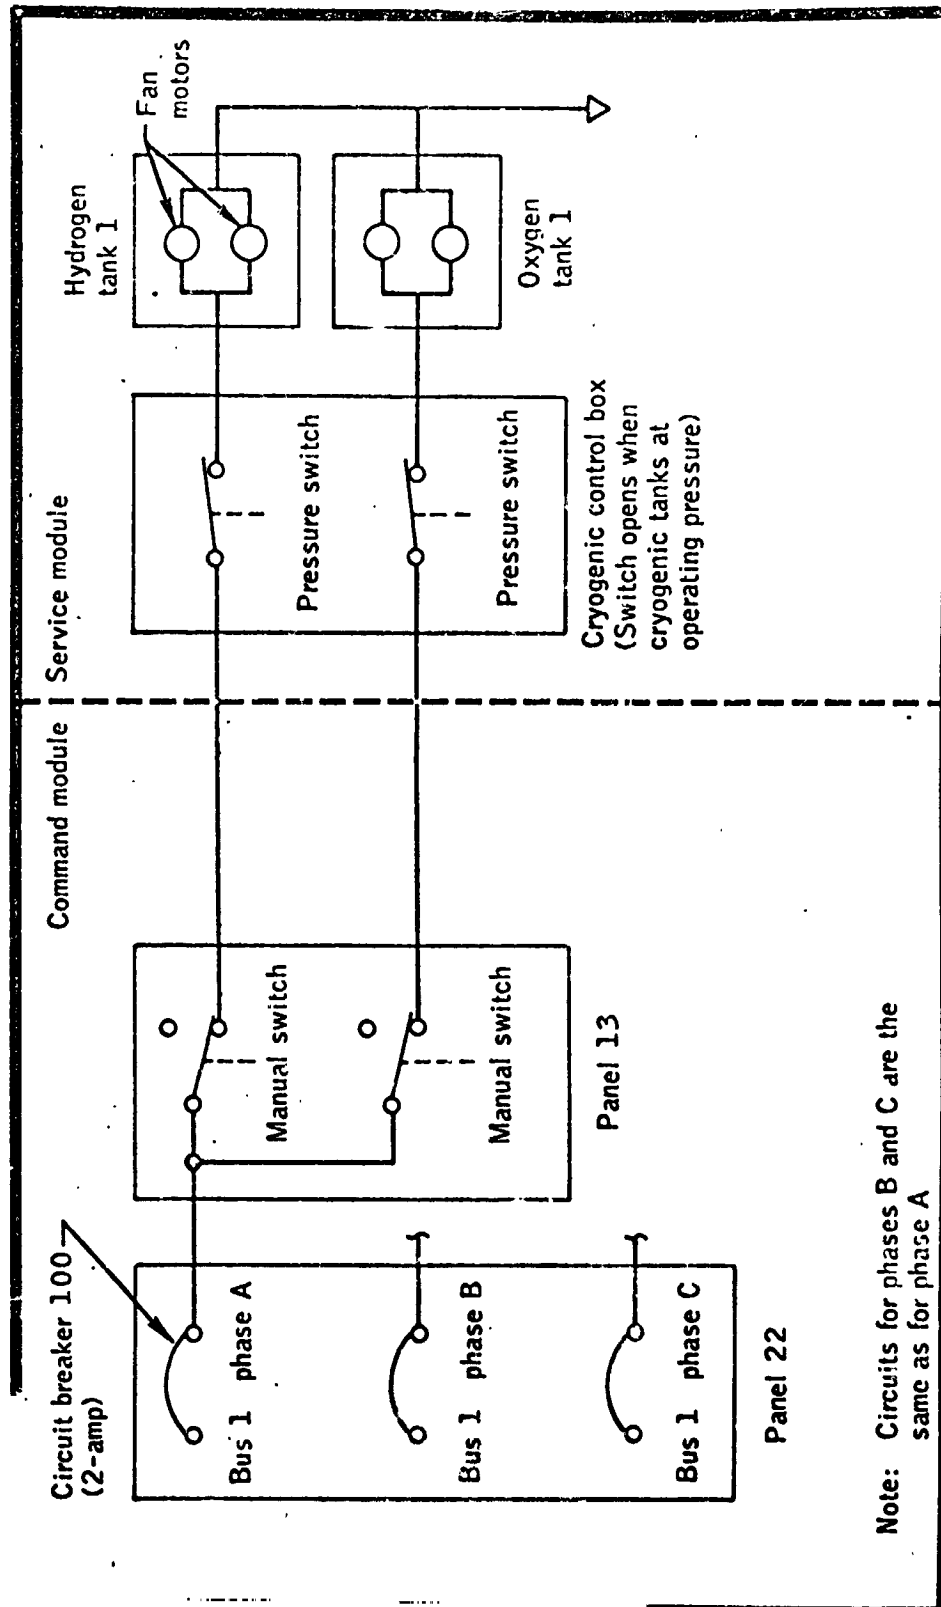
Figure 2.1.1.5-1. Fan motor circuit for hydrogen and oxygen tank 1.

| <p>STATUS: THE PROBABLE CAUSE OF LOAD SWITCHING WAS A SINGLE-PHASE FAULT TO GROUND IN A FAN MOTOR IN OXYGEN TANK 1, WHICH WAS CLEARED BY THE CIRCUIT BREAKER. THE BLOCK II CRYOGENIC TANK FANS ARE OF AN IMPROVED DESIGN WITH GREATER RELIABILITY. FOR CSM 103, 104, 106 AND SUBSEQUENT, EACH INDIVIDUAL FAN MOTOR HAS FUSE PROTECTION IN EACH PHASE TO PREVENT A FAULT IN ONE FAN MOTOR FROM CAUSING THE CIRCUIT BREAKER POWERING FOUR FANS TO OPEN. THIS ANOMALY HAS BEEN CLOSED BY MSC.</p> | | |

THE ESSENTIAL AC LOADS WERE TRANSFERRED FROM AC BUS 1 TO AC BUS 2 AS A RESULT OF A SHORT IN THE CRYOGENIC TANK NO. 1 CIRCUIT. THE MOST PROBABLE CAUSE WAS A FAULT TO GROUND IN PHASE A OF THE OXYGEN TANK NO. 1 FAN MOTOR CIRCUIT.

NO CORRECTIVE ACTION IS REQUIRED. BLOCK I FAN MOTORS HAD SEVERAL FAILURES BECAUSE OF PHASE-TO-GROUND FAULTS. THE BLOCK II FANS WERE REDESIGNED TO PREVENT THIS OCCURRENCE BY CHANGING THE WIRE LENGTH AND ROUTING, IN ADDITION TO OTHER DESIGN CHANGES. ALL EIGHT FANS (TWO FANS PER TANK) IN CSM 103, 104, 106, AND SUBSEQUENT WILL BE PROTECTED BY INDIVIDUAL FUSES IN EACH PHASE OF THE MOTOR SO THAT A FAULT IN ONE MOTOR WILL NOT RESULT IN AN OPEN CIRCUIT BREAKER THAT WOULD CAUSE LOSS OF POWER TO FOUR FAN MOTORS.

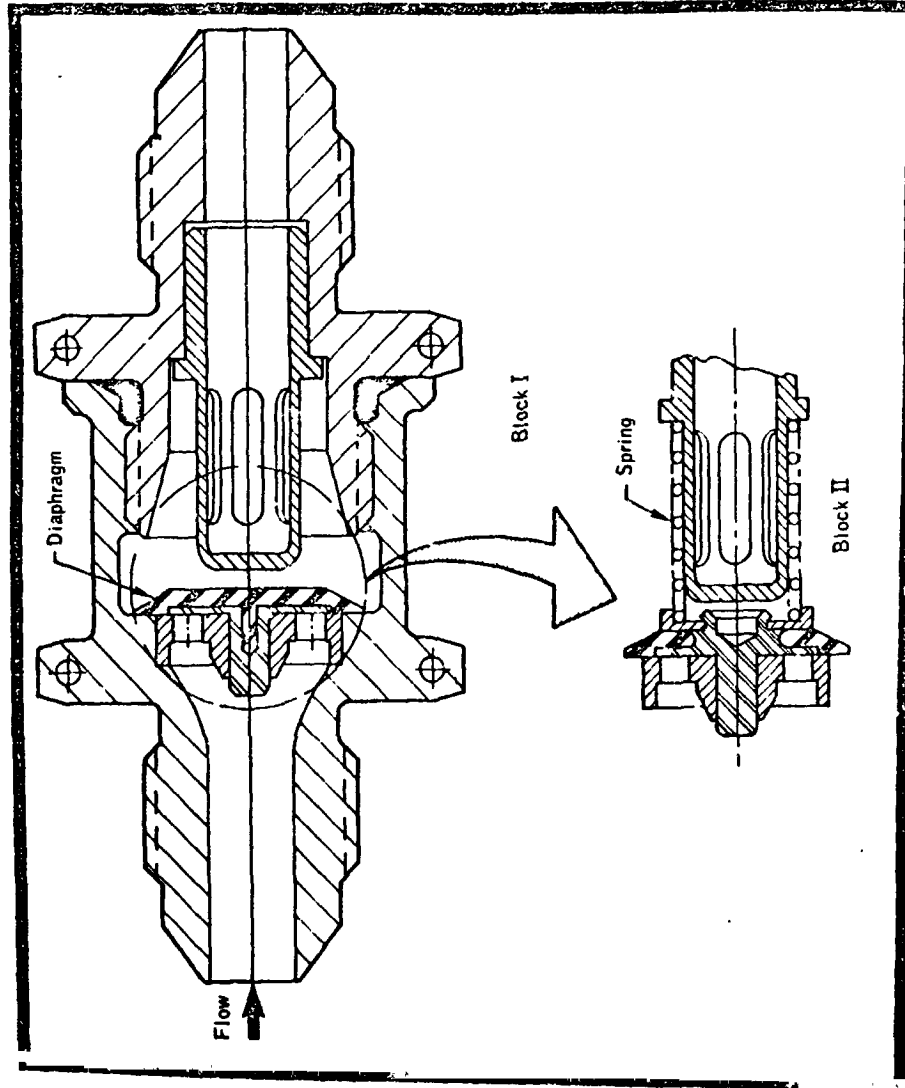
Figure 2.1.8-1. OXYGEN CHECK VALVE

| DESCRIPTION: | <p>THE PRESSURE IN THE ECS OXYGEN SURGE TANK WAS OBSERVED TO VARY IN PHASE WITH THE PRESSURE IN CRYOGENIC OXYGEN SUPPLY TANK 2. THIS INDICATES THAT ONE OR BOTH OF THE OXYGEN INLET RESTRICTOR ASSEMBLY CHECK VALVES FAILED TO SEAT WHEN THE CRYOGENIC TANK 2 PRESSURE DECREASED BELOW THE SURGE TANK PRESSURE. THE ECS PERFORMANCE WAS NOT ADVERSELY AFFECTED BECAUSE THERE WAS NO FAILURE IN ANY OTHER PORTION OF THE SYSTEM.</p> | |
| STATUS: | <p>DURING POST-FLIGHT BENCH TESTING, BOTH OF THE CHECK VALVES LEAKED IN THE REVERSE DIRECTION AT DIFFERENTIAL PRESSURES LESS THAN 25 PSI. THERE WAS NO EVIDENCE OF CORROSION OR CONTAMINATION. A HISTORY OF SIMILAR FAILURES ON BLOCK I CHECK VALVES HAS RESULTED IN A DESIGN CHANGE FOR BLOCK II CHECK VALVES. THE BLOCK I CHECK VALVE SEATING IS ACCOMPLISHED BY A DIAPHRAGM OPERATED BY DIFFERENTIAL PRESSURE; FOR BLOCK II VALVES, THE DIAPHRAGM SEATING HAS BEEN AUGMENTED BY THE ADDITION OF A SPRING TO ASSURE SEATING UNDER LOW DIFFERENTIAL PRESSURE (SEE FIGURE 2.1.8-1). THIS ANOMALY HAS BEEN CLOSED BY MSC.</p> | |

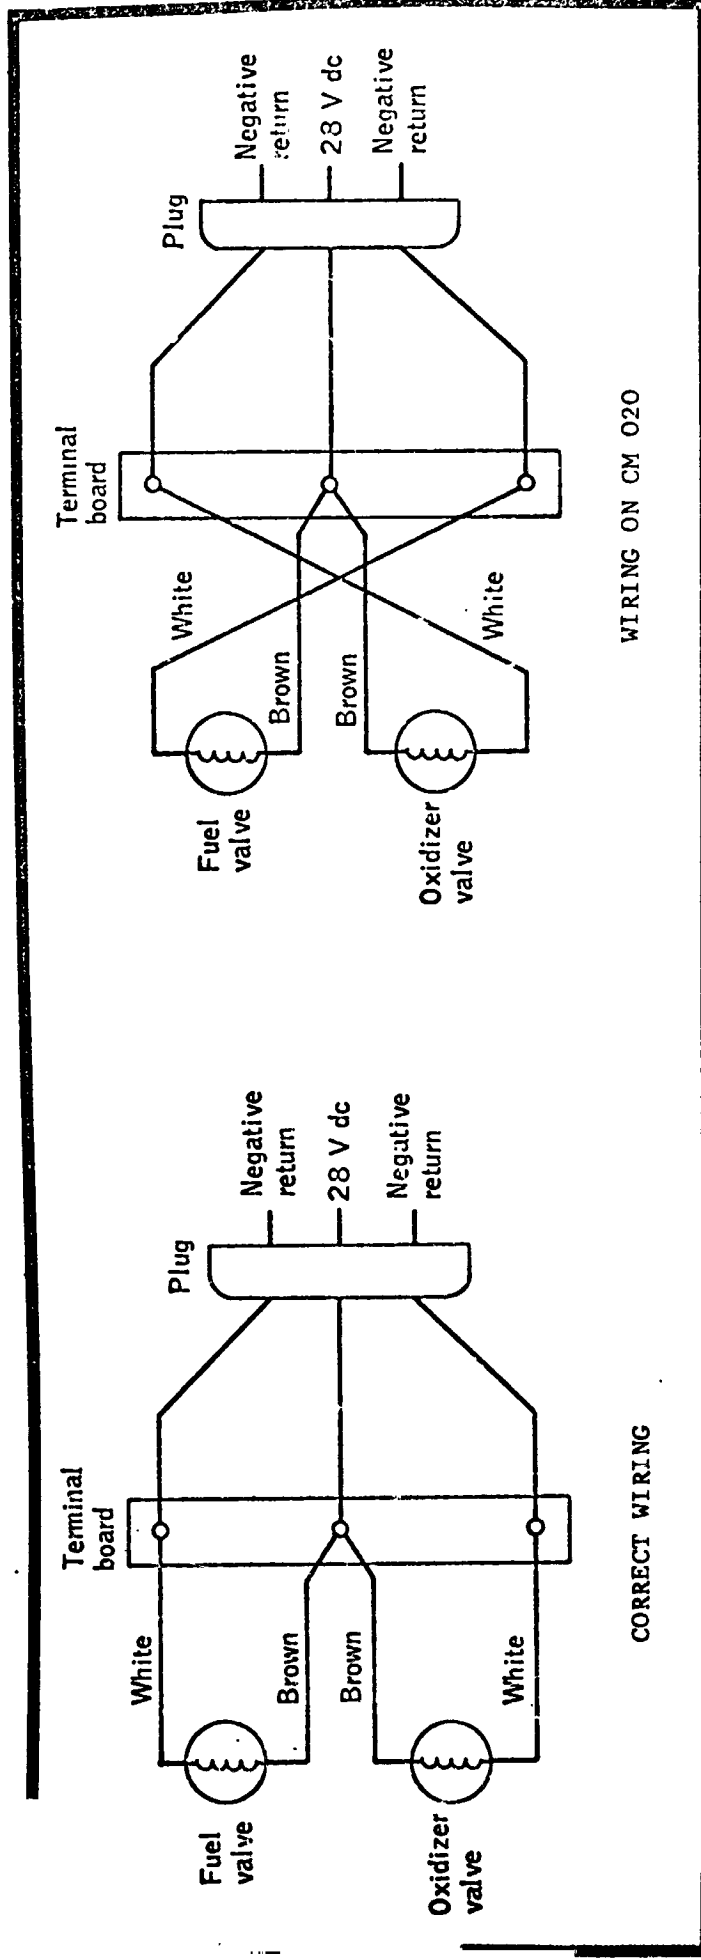
Figure 2.1.12-1. YAW ENGINE WIRING

| <p>NO. 2.1.12</p> <p>SYSTEM: CM</p> <p>SUBSYSTEM:</p> | <p>TITLE: CROSSWIRING OF CM RCS VALVES</p> <p>MISSION: APOLLO 6 POST-FLIGHT TESTING</p> <p>EVENT TIME:</p> <p>DESCRIPTION: DURING THE DE-ACTIVATION OF THE CM REACTION CONTROL SYSTEM, THE CONNECTOR FROM THE REACTION CONTROL SYSTEM CONTROL BOX TO THE ENGINE VALVES WAS REMOVED AND RECONNECTED TO GROUND SUPPORT EQUIPMENT FOR VALVE ACTUATION. WHEN THE MINUS YAW AND THE PLUS YAW FUEL VALVES WERE OPENED, BROWNISH-RED VAPOR CLOUDS AND LIQUID DROPLETS INDICATIVE OF OXIDIZER WERE OBSERVED. FUEL WAS NOTED WHEN THE MINUS YAW AND THE PLUS YAW OXIDIZER VALVES WERE ACTIVATED. A PRE-FLIGHT GAS FLOW CHECK NORMALLY DEMONSTRATES ENGINE OPERATION, BUT THE VALVES ARE NOT CHECKED INDIVIDUALLY.</p> <p>STATUS: A POST-FLIGHT TEST HAS SHOWN THAT THE ELECTRICAL WIRES TO THE FUEL AND OXIDIZER VALVES WERE CROSSED ON ALL FOUR YAW ENGINES AS SHOWN IN FIGURE 2.1.12-1. THE WIRES TO THE VALVES WERE THE SAME COLOR, CAME FROM THE SAME AREA, AND WERE NOT SEPARATELY IDENTIFIED. THE CROSSED WIRES WERE BETWEEN THE TWO VALVES ON EACH ENGINE, NOT BETWEEN VALVES ON DIFFERENT ENGINES. VALVE WIRING WAS NOT INDEPENDENTLY VERIFIED AFTER INSTALLATION. THE RCS OPERATED SATISFACTORILY IN FLIGHT BECAUSE THE OXIDIZER AND FUEL VALVES ARE WIRED IN PARALLEL AND RECEIVE A COMMON COMMAND SIGNAL. ON THIS MISSION, THE PROPELLANTS WERE DUMPED BEFORE LANDING AND ONLY VAPOR REMAINED IN THE TANKS AT DE-ACTIVATION. ON APOLLO 7, AND POSSIBLY OTHER MISSIONS, THE PROPELLANTS WILL NOT BE DUMPED BEFORE LANDING AND MIXING OF PROPELLANTS IN THE COLLECTION TANKS COULD OCCUR. A SPECIAL FUNCTIONAL TEST OF INDIVIDUAL VALVE ACTUATION WILL BE PERFORMED ON ALL BLOCK II SPACECRAFT. PROPER WIRING HAS BEEN VERIFIED ON CM 101 (APOLLO 7), 103 AND 104. IN ADDITION, ON CM 102, 106 AND SUBS., THIS WIRING WILL HAVE IDENTIFICATION SLEEVING. THIS ANOMALY HAS BEEN CLOSED BY MSC.</p> |

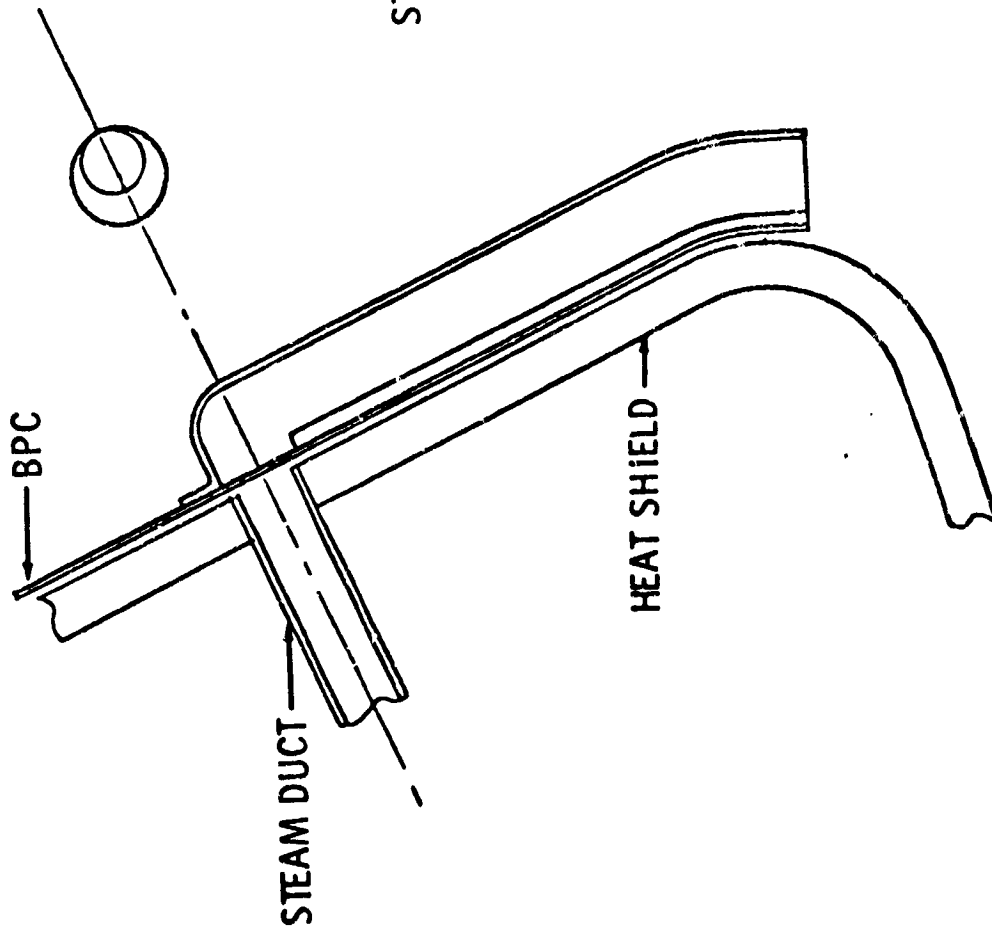
Figure 2.1.13-1
STEAM DUCT VENT THROUGH BPC

TESTS CONDUCTED BY NR INDICATE THAT THERE MAY HAVE BEEN NO HOLE IN THE BOOST PROTECTIVE COVER, THEREBY RESTRICTING FLOW THROUGH THE STEAM DUCT. A BOOST PROTECTIVE COVER WAS FOUND WHICH HAD NO HOLE TO VENT STEAM DUCT FLOW, THOUGH ALL DOCUMENTATION INDICATED THAT THE HOLE SHOULD BE PRESENT. TESTS SIMULATING THE EFFECT OF THIS CONDITION MATCHED THE FLIGHT DATA FROM APOLLO 6 (SEE FIGURE 2.1.13-2).

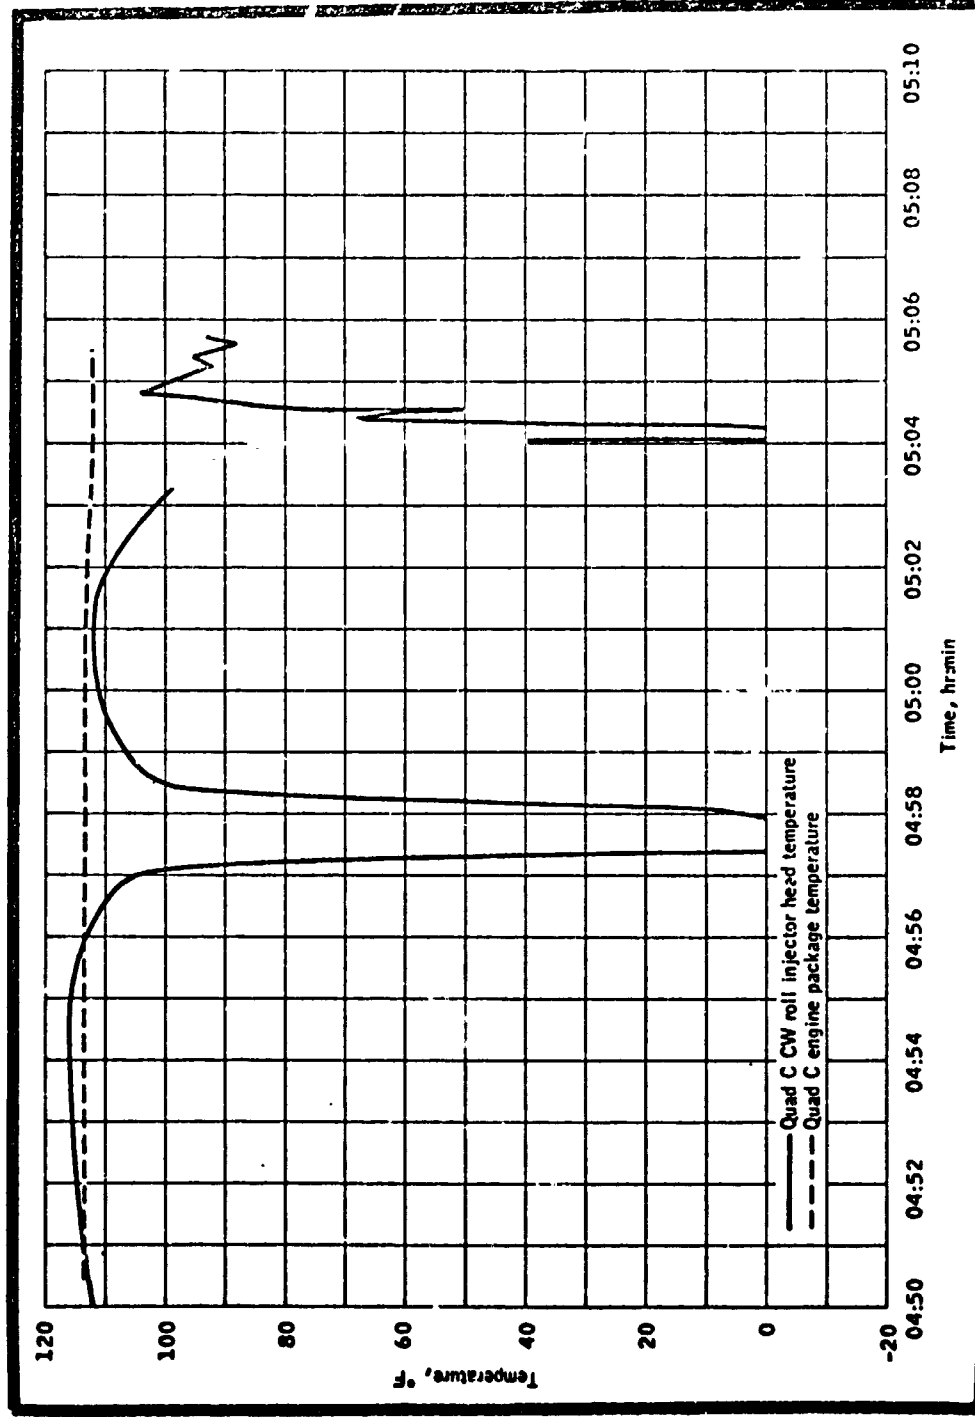
Figure 2.1.17-1. Typical Quad C Temperature Excursions

THE QUAD C HEATERS WERE ACTUATED "ON" AT APPROXIMATELY 03:50:00 AT A MOUNTING STRUCTURE TEMPERATURE OF 114°F AND REMAINED ON THROUGHOUT THE ENTIRE COLD-SOAK PERIOD. THE MOUNTING STRUCTURE TEMPERATURE QUICKLY INCREASED TO 122.5°F THEN UNDERWENT A GRADUAL DECLINE, REACHING 86°F AT THE TERMINATION OF THE COLD-SOAK PERIOD. IN GENERAL, THE INJECTOR TEMPERATURE REMAINED 4° TO 6°F ABOVE THE MOUNTING STRUCTURE TEMPERATURE. DURING FOUR PERIODS BETWEEN 03:45:00 AND 05:32:00, HOWEVER, THE INDICATED TEMPERATURE OF THE CLOCKWISE ROLL ENGINE INJECTOR (THE ONLY ONE INSTRUMENTED IN THE QUAD) DECREASED SHARPLY (SEVERAL TIMES GOING BELOW 0°F), AND THEN RECOVERED TO ITS ORIGINAL TEMPERATURE AT ESSENTIALLY THE SAME RATE. AN EXAMPLE OF THIS BEHAVIOR BETWEEN 04:55:00 AND 05:05:00 IS SHOWN IN FIGURE 2.1.17-1.

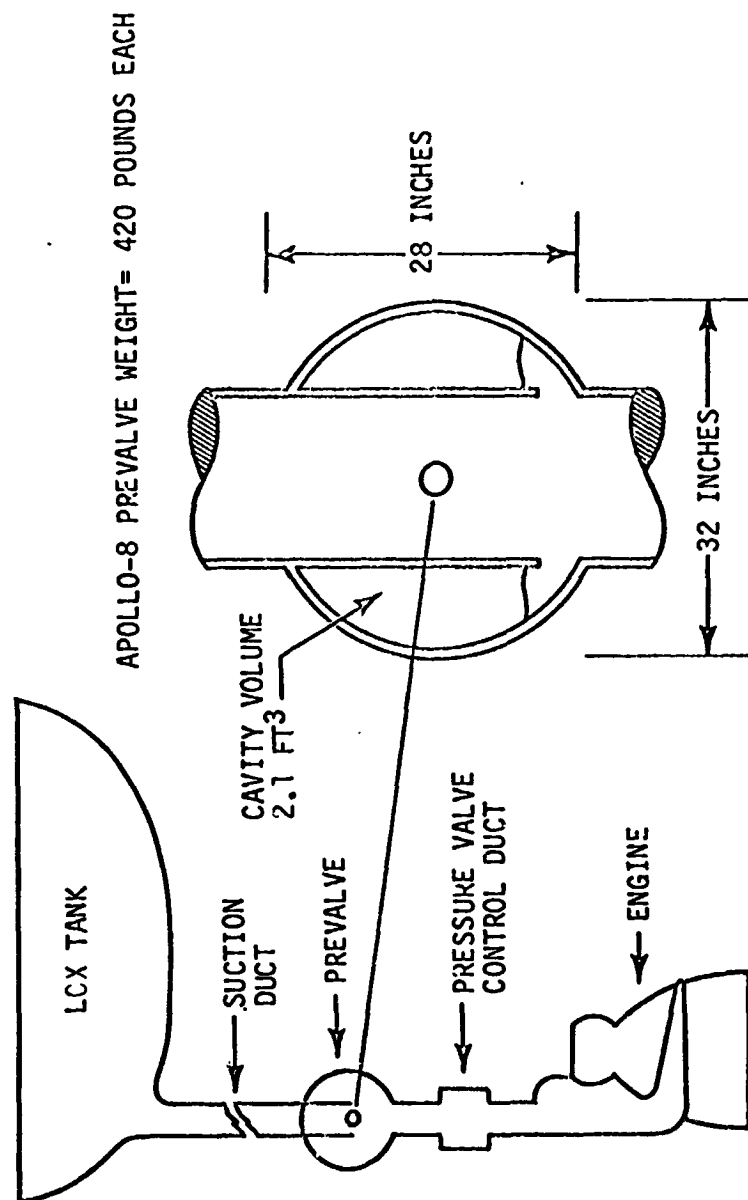
Figure 2.2.1-1

ORIGINAL STABILITY ANALYSIS INDICATED ADEQUATE MARGINS WITH PREVALVE ACCUMULATORS INSTALLED IN ALL S-IC ENGINES. FURTHER INVESTIGATION INTO THE CENTER ENGINE STABILITY REVEALED A COUPLING OF THE LOX LINE SECOND MODE WITH THE CENTER ENGINE STRUCTURAL MODE AND PRODUCED INSTABILITY FROM APPROXIMATELY T+40 TO T+87 SECONDS. ANALYSIS USING PREVALVE ACCUMULATORS, IN THE FOUR OUTBOARD ENGINE LINES ONLY, INDICATED STABLE CONDITIONS IN ALL MODES THROUGHOUT S-IC BOOST. S-IC-7 WAS STATIC FIRED SATISFACTORILY USING FOUR OUTBOARD ENGINE LOX LINE ACCUMULATORS. THE FOUR ENGINE ACCUMULATOR SYSTEM DOES NOT ADVERSELY AFFECT THE GUIDANCE SYSTEM STABILITY OR PRODUCE SIGNIFICANT LONGITUDINAL/LATERAL LOADS IN THE SPACECRAFT. THE USE OF THE FOUR ENGINE LINE ACCUMULATOR CONFIGURATION WAS RECOMMENDED FOR USE FOR APOLLO 8. THE S-II ANALYSIS INDICATED ADEQUATE POGO STABILITY MARGINS AT IGNITION AND CUTOFF. THE RESULTS OF THE REMAINING S-II POWERED FLIGHT ANALYSIS WILL BE AVAILABLE NOVEMBER 11, 1968. THE S-IVB ANALYSIS INDICATED ADEQUATE POGO STABILITY MARGINS THROUGHOUT FLIGHT.

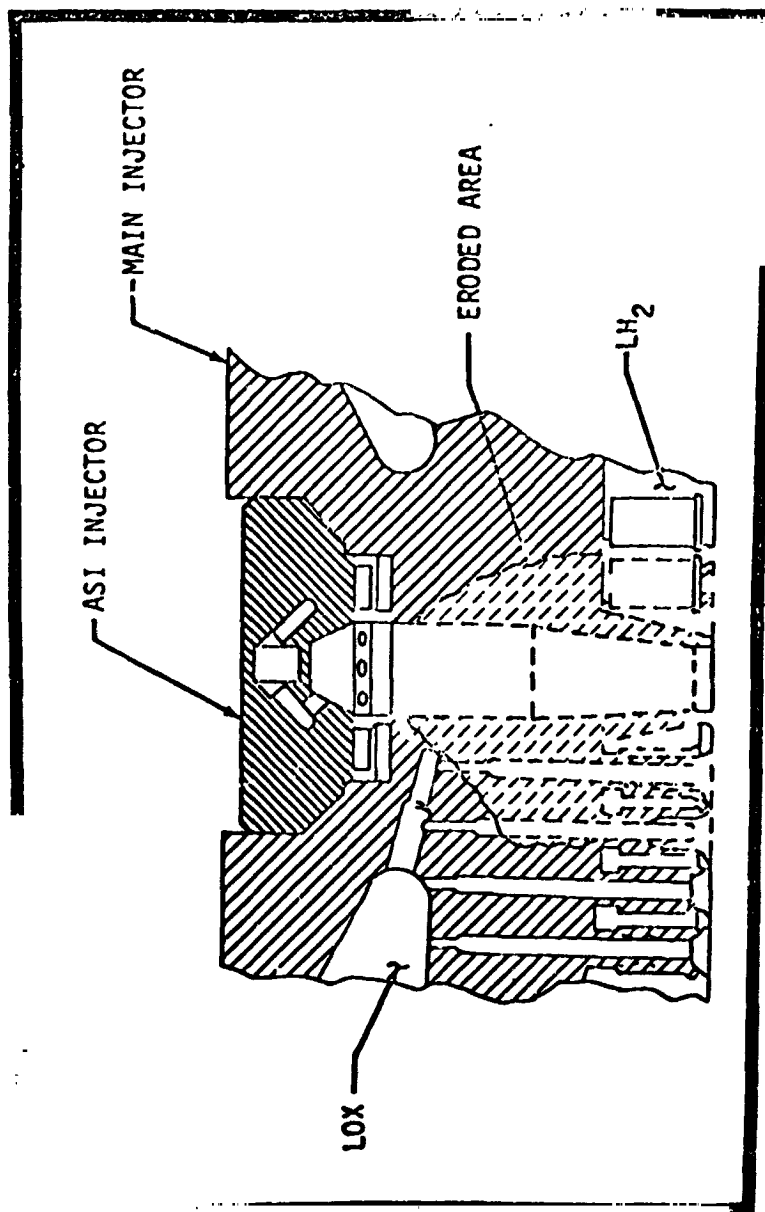
Figure 2.2.2-1

TESTING AT THE MARSHALL SPACE FLIGHT CENTER AND ENGINE MANUFACTURER'S FACILITY SUBSTANTIATED THE THEORY THAT ENGINE NUMBER 2 FAILURE WAS CAUSED BY EROSION OF THE LOX DOME. AN ASI FUEL LINE FAILURE WAS SIMULATED BY REDUCING THE FUEL SUPPLY, CREATING AN ASI 9.5 LOX/LH2 MIXTURE RATIO. THE HIGH MIXTURE RATIO PRODUCED ABNORMALLY HIGH TEMPERATURES IN THE MAIN INJECTOR, WHICH CAUSED SEVERE EROSION TO OCCUR.

S-II Injector After 28 Second Test at High ASI Mixture Ratio

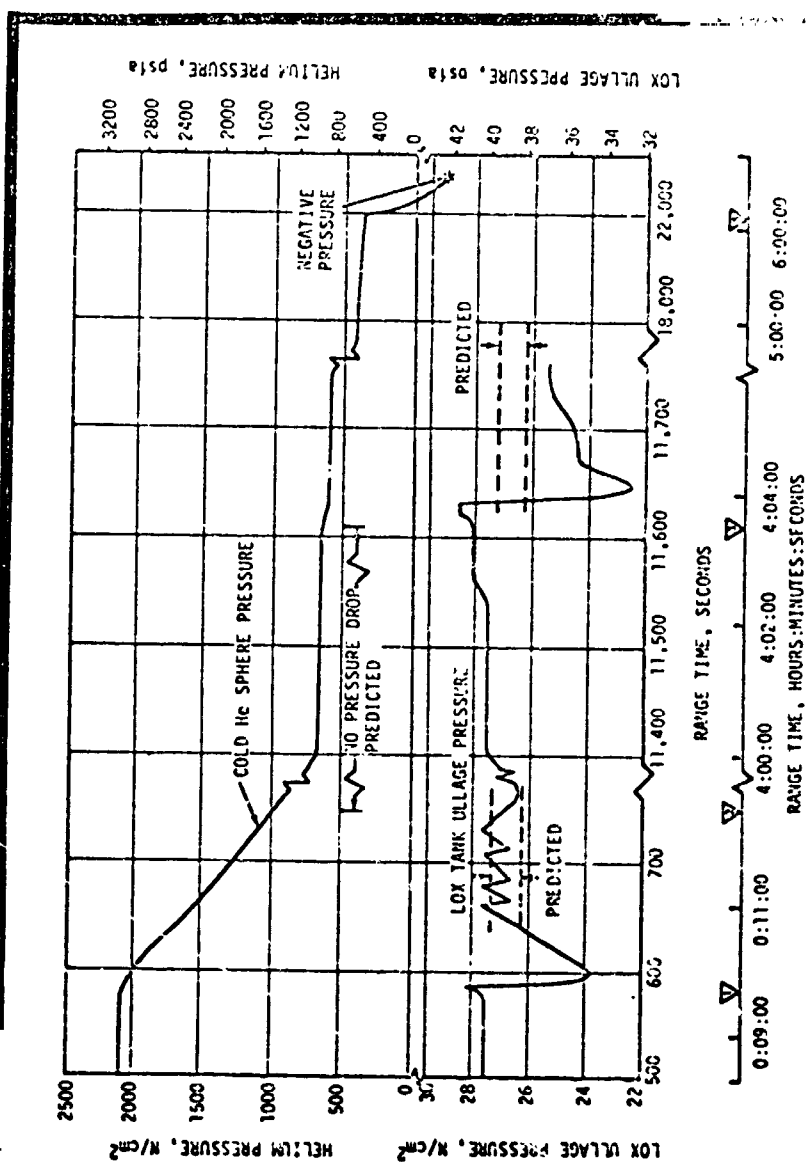
APOLLO 6 S-IVB COLD HELIUM SUPPLY DECAY
FIGURE 2.2.7-1

FOR APOLLO 6 THE COLD HELIUM SUPPLY WAS ADEQUATE TO MEET ALL FLIGHT REQUIREMENTS. AT FIRST BURN ESC THE COLD HELIUM SPHERES CONTAINED 151 KILOGRAMS (332 lbm) OF HELIUM AT A PRESSURE 2027 N/cm² (2940 psia). AT THE END OF THE 166.52-SECOND ENGINE BURN, THE HELIUM MASS HAD DECREASED TO 124 KILOGRAMS (273 lbm) AT A PRESSURE OF 951 N/cm² (1380 psia). FOLLOWING FIRST BURN ECO N/cm²/min (2.9 psi/min) AS SHOWN IN FIGURE 2.2.7-1, RESULTING IN AN APPARENT PRESSURE AT SECOND BURN ESC OF 593 N/cm² (860 psia).

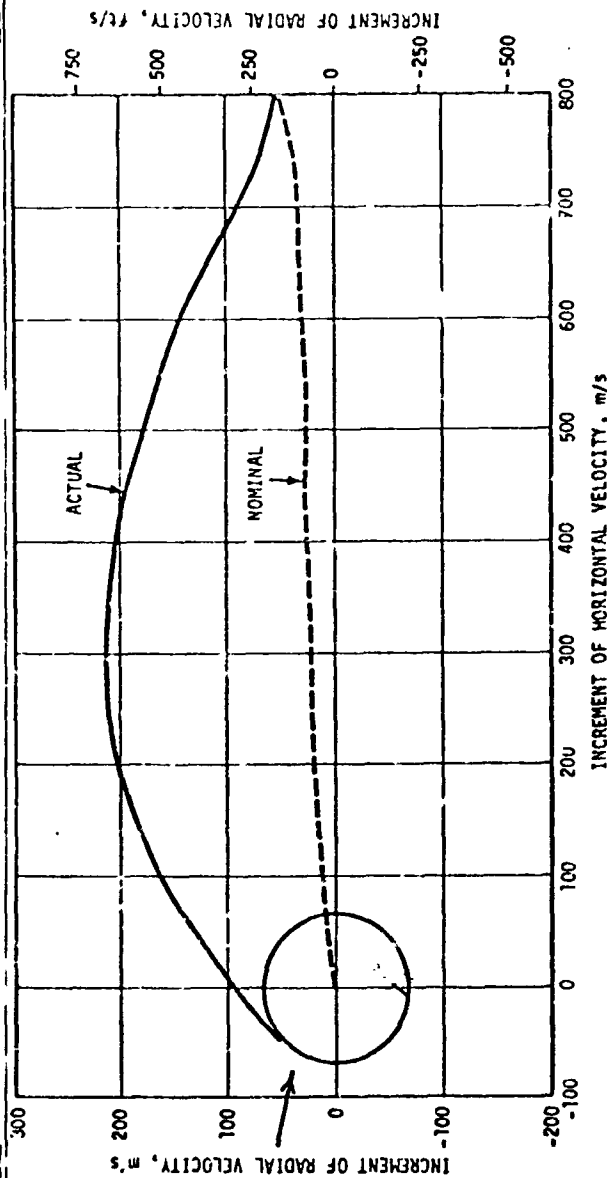
FIGURE 2.2.15-1

ON ENTERING THE CUTOFF LOOP, THE AS-502 TOTAL VELOCITY WAS IN EXCESS OF THE DESIRED VALUE OF 7790.9 M/S (25,560.7 FT/S), AND CUTOFF SIGNAL WAS IMMEDIATELY GIVEN AT 747.04 SECONDS WITH AN OVERSPEED OF 48.9 M/S (160 FT/S).

FIGURE 1 IS A PLOT OF THE RADIAL VELOCITY (X_y) TO-BE-GAINED VERSUS THE HORIZONTAL VELOCITY (Z_y) TO-BE-GAINED. THE CIRCLE ABOUT THE ORIGIN REPRESENTS THE CUTOFF LOOP WHICH IS ENTERED WHEN TOTAL VELOCITY-TO-BE-GAINED FALLS BELOW APPROXIMATELY 65 M/S (213 FT/S). THE DIFFERENCE IN THE ACTUAL AND NOMINAL VELOCITIES-TO-BE-GAINED IS A RESULT OF PITCH DOWN ATTITUDE COMMANDS TO CORRECT ALTITUDE DURING THE INITIAL PORTION OF S-IVB GUIDANCE. THE PITCH DOWN ATTITUDE TENDED TO INCREASE THE RADIAL VELOCITY-TO-BE-GAINED RATHER THAN DECREASE IT.
